Vincenzo Riso

Álvaro Siza's Lordelo do Ouro Cooperative Building

Álvaro Siza's Lordelo do Ouro Cooperative Building: Preliminary Studies towards the Conservation of a Masterpiece in Need of Recognition

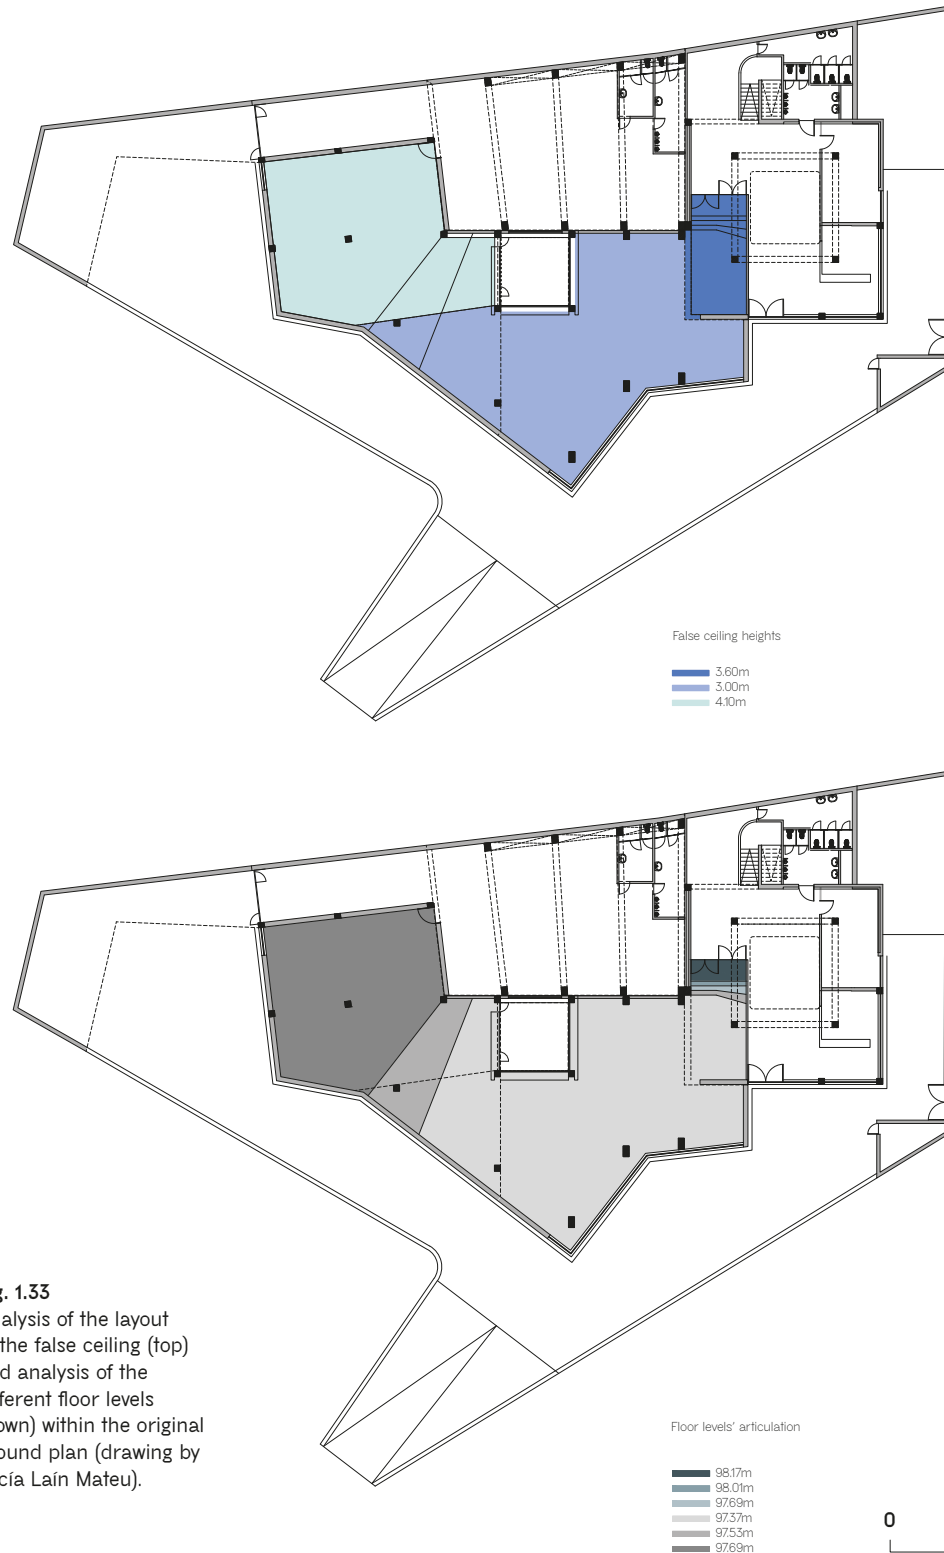
Fig. 1.33
Analysis of the layout
of the false ceiling (top)
and analysis of the
different floor levels
(down) within the original
ground plan (drawing by
Lucia Lain Mateu).

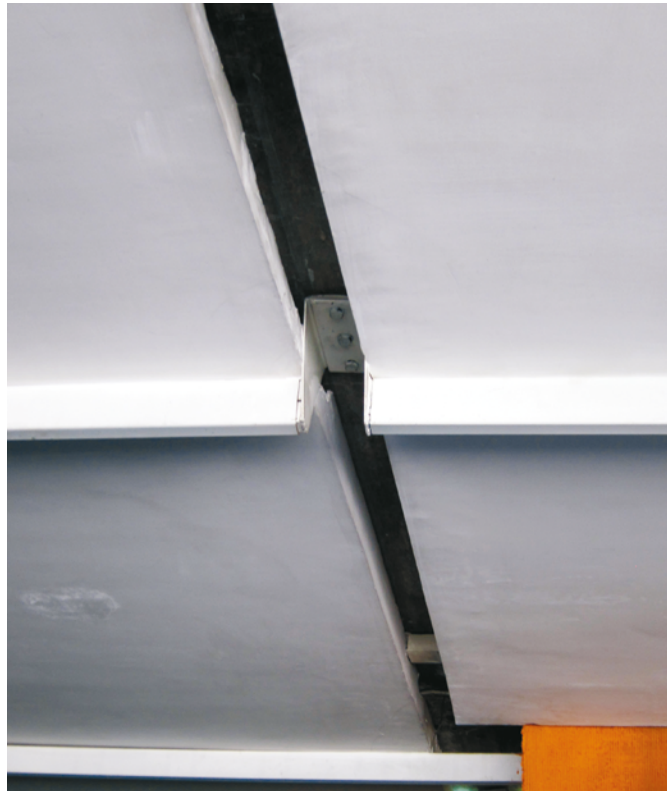
Fig. 1.35

Detail view of a remaining segment of the splits that originally patterned the false ceilings along the extension of the concrete beams; the support brackets also visible are part of the later added support framework (photo by the author 2017-19).

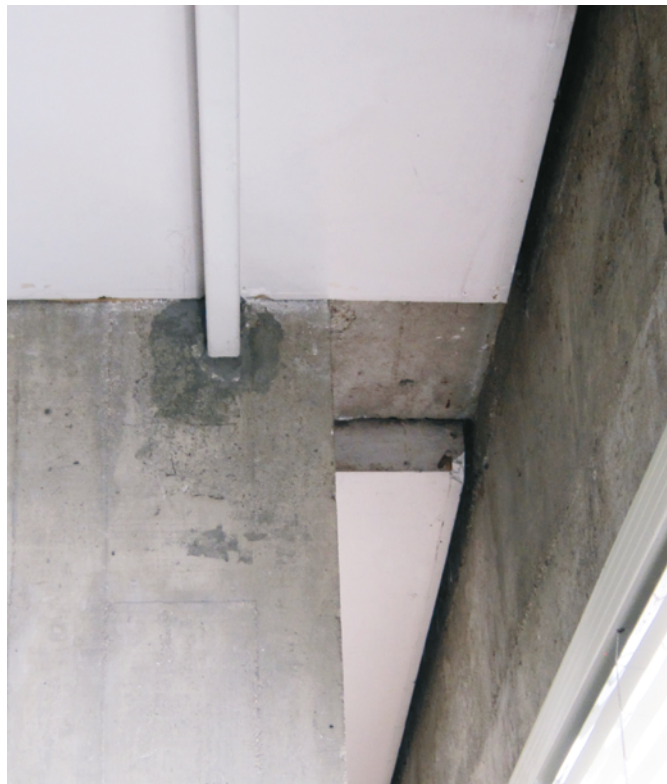
**Fig. 1.36**

Detail view of the open joint between the false ceilings and the walls; the steel profile element, also visible, is part of the later added support framework (photo by the author 2017-19).

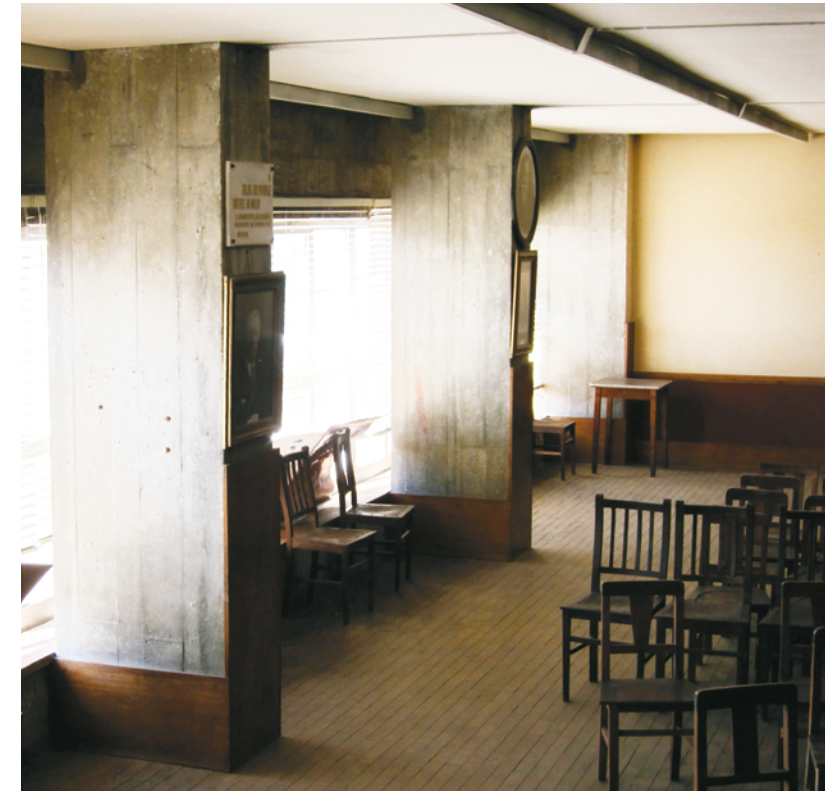
**Fig. 1.37**

Inside view of the assembly hall, in which the splits that originally patterned the false ceilings along the extension of the concrete beams can still be seen; the steel profile elements, also visible, are part of the later added support framework (photo by the author 2017-19).

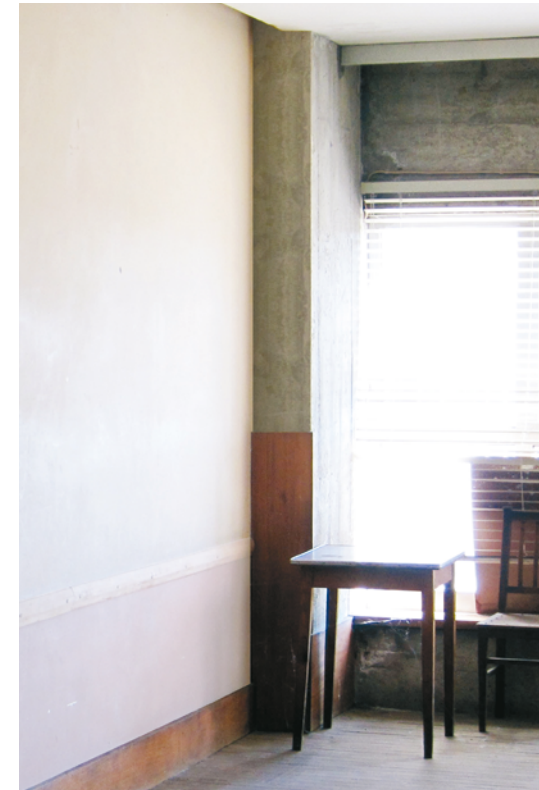
Fig. 1.40
View of an intersection among a partition wall, a pillar and the façade's structural wall, which are joined together by the material continuity of a sequence of coating wooden strips and boards. The layout of the false ceiling, which was originally meant to appear as a floating and hanging surface, is also observable (photo by the author 2017–19).

Concerning the interior finishing, it is worth observing that when it comes to the intersections among the various structural components (exposed concrete pillars, beams, slabs and walls), and their interplay with non-structural walls, an additional role is played by wood (*Prioria balsamifera* that came from Angola under the Portuguese name of *Tola*) coating elements (strips and boards). Anyway, this is again an empirical (i.e. not rigid, rather point by point adjusted) formula. In fact, on occasion spatial perception may take relevance and affirm itself as a unifying principle. Like, for instance, in the case of the expansion joint which appears to be absorbed into the staircase in the continuity of a plastered wall, and therefore designed as some kind of thin furrow contour along the adjoining lines of the different structural bulks (such a line is visible on the left, Fig. 1.44). That is to say that in this specific part we have a concrete beam that is supporting an insulation masonry brick wall; so they are visually united by the gypsum plastering, while the joint line described above makes the presence of the structural element manifest, and manages the cracking line necessarily originated from the different expansion behavior of the concrete beam versus the brick masonry [Figs. 1.40 to 1.47].

Note regarding Figures 1.40 to 1.46: opacified white parts correspond to the altered ones, flooring materials shown in those images are also not the originals.

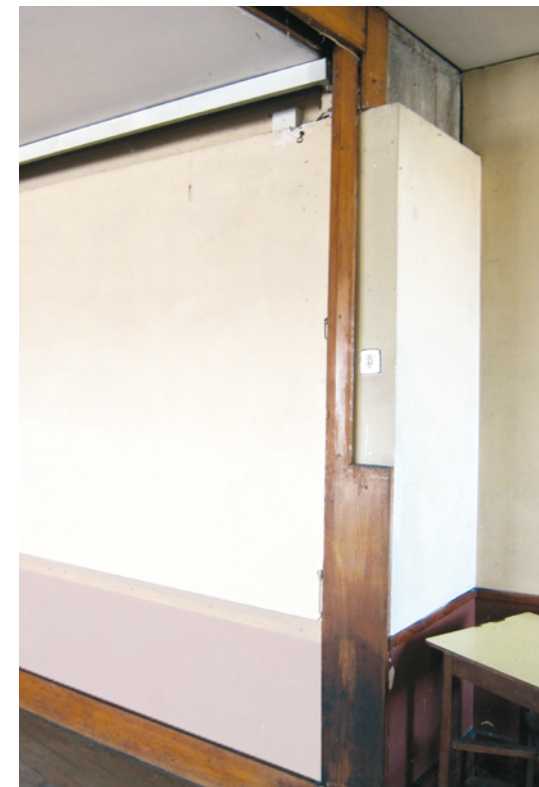
Fig. 1.41
View of the wood and plaster finishing of the pillar – which is opposite to the pillar shown in Fig. 1.40 – placed at the entrance of the assembly hall (photo by the author 2017–19).

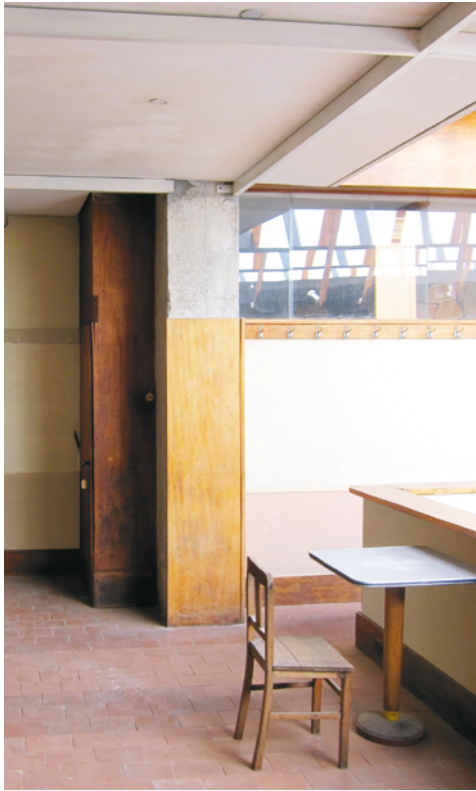
Fig. 1.42

View of the wood finishing at the point where a pillar and the partition wall intersect, which encloses the library placed at the tower block's second floor. Note that – as explained along the text – the lattice structure appears in the ceiling due to a subsequent alteration (photo by the author 2017-19).

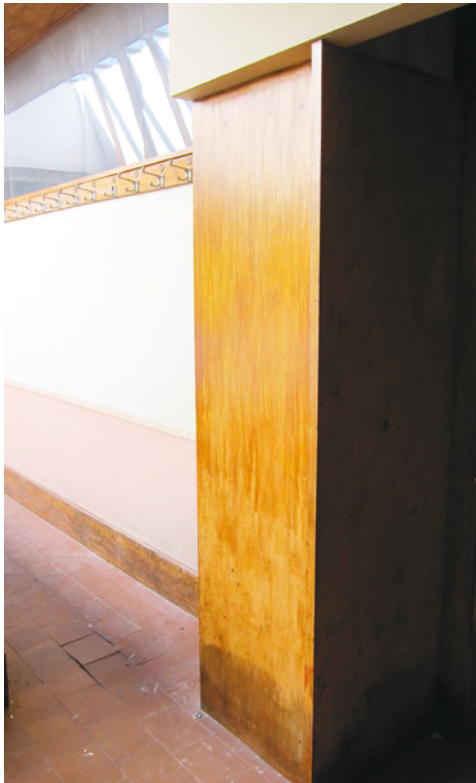
**Fig. 1.43**

Detail view of the wood finishing of the pillar – which is opposite to the pillar shown in Fig. 1.42 (photo by the author 2017-19).

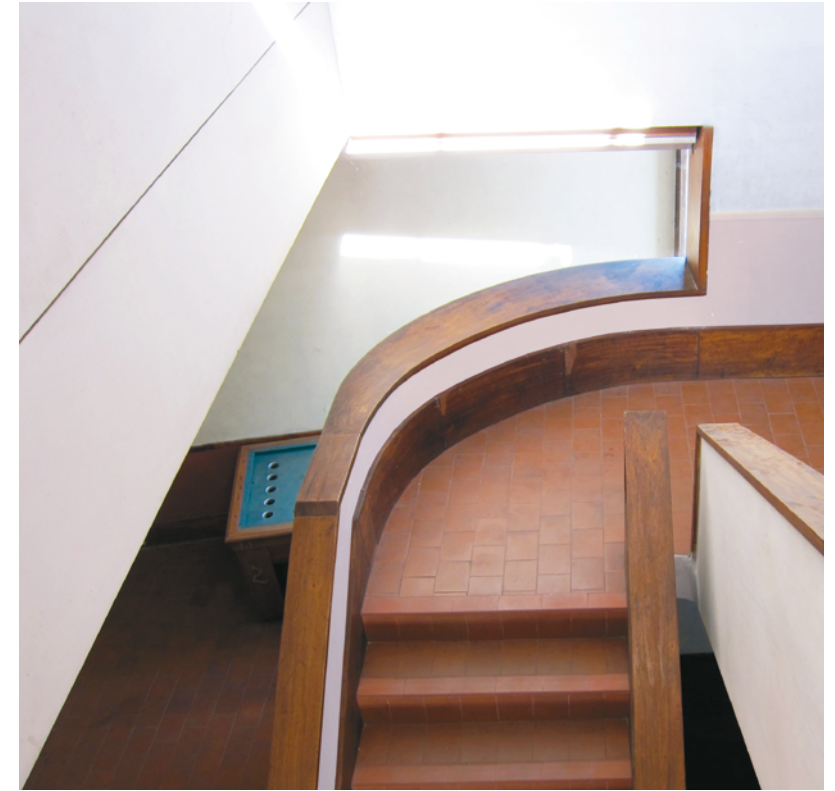
**Fig. 1.44**

View of the wood finishing along the inside of the staircase between the first and second floors (photo by the author 2017-19).

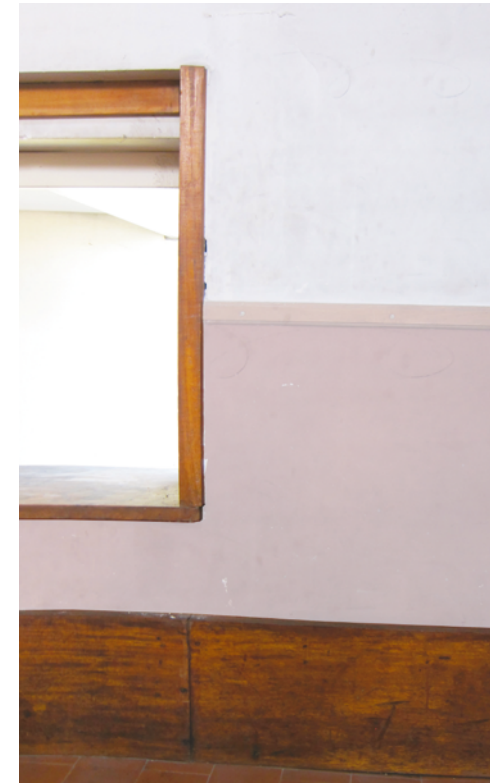
**Fig. 1.45**

Detail of a portion of the finishing portrayed in Fig. 1.44 (photo by the author 2017-19).

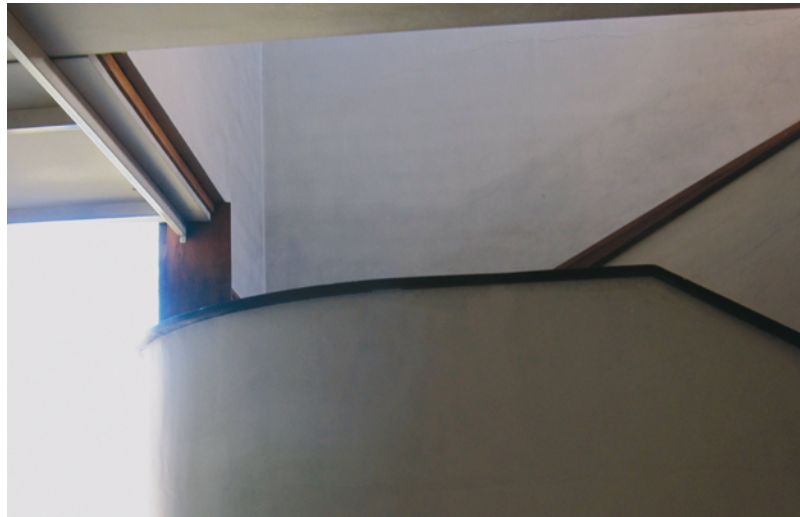
Fig. 1.46

View of the stair landing between the first and second floors (photo by the author 2017–19).

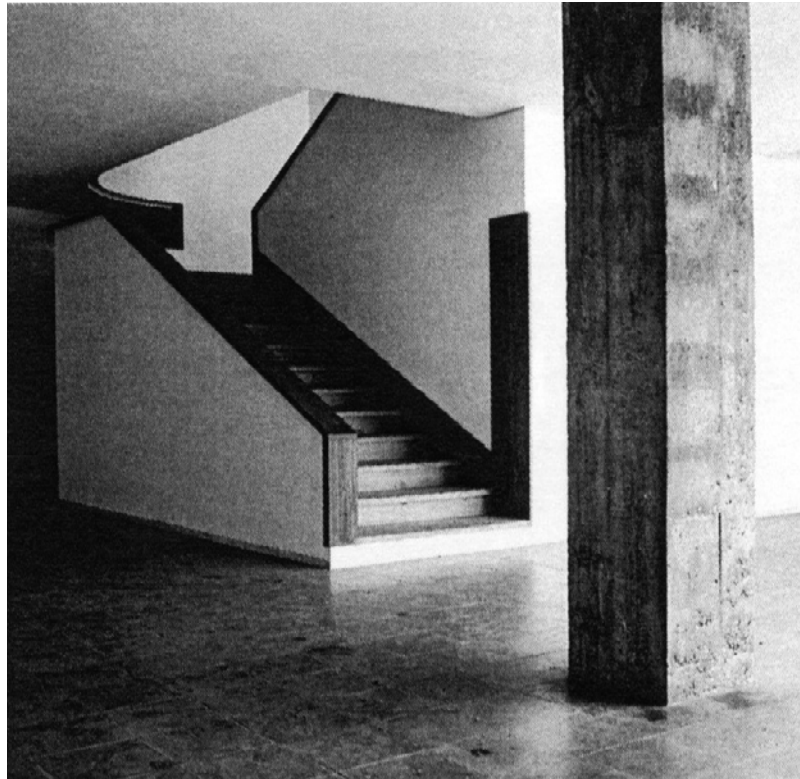
**Fig. 1.47**

Historical photo (1960–63) of the same stair landing between the first and second floors, where it is evident that the flooring has been altered too (Álvaro Siza Archive © Serralves Foundation).

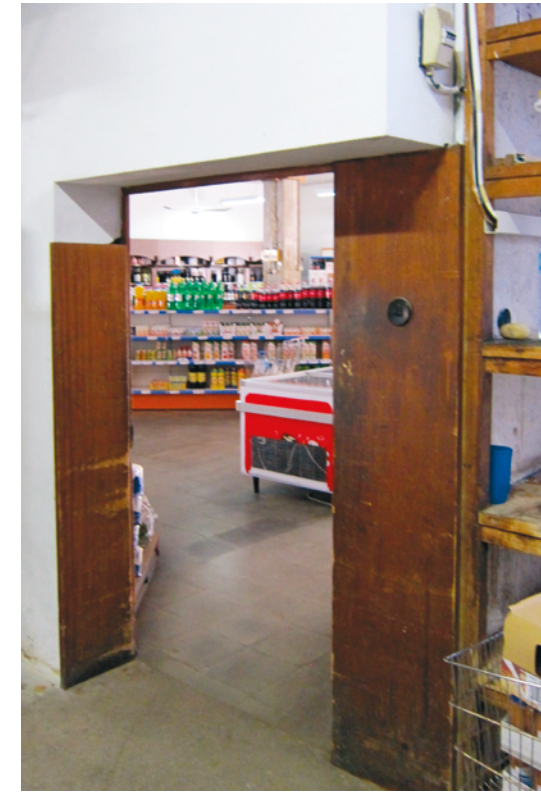
Fig. 1.55

Door between the sales hall and the storage room, which is among the few remaining original elements (photo by the author 2017-19).

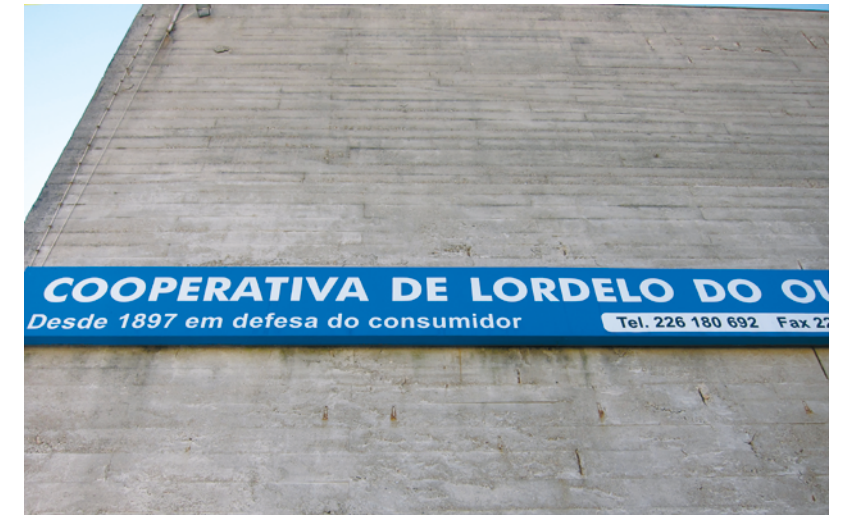
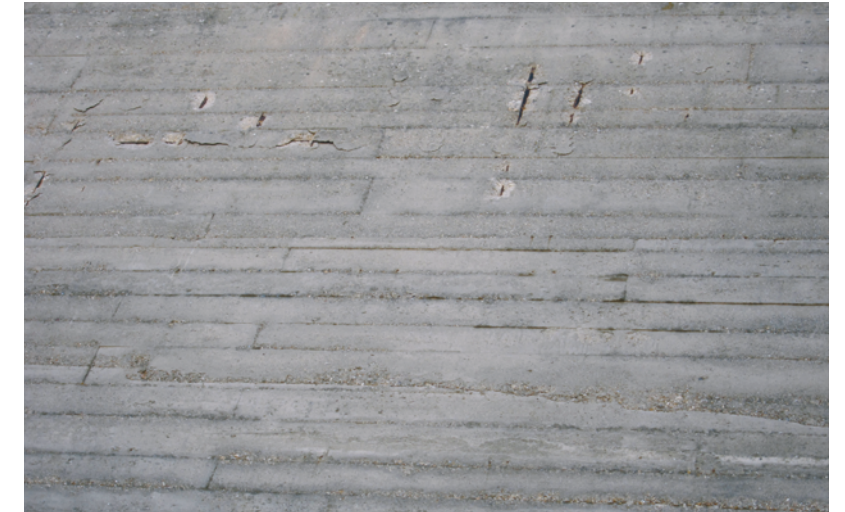
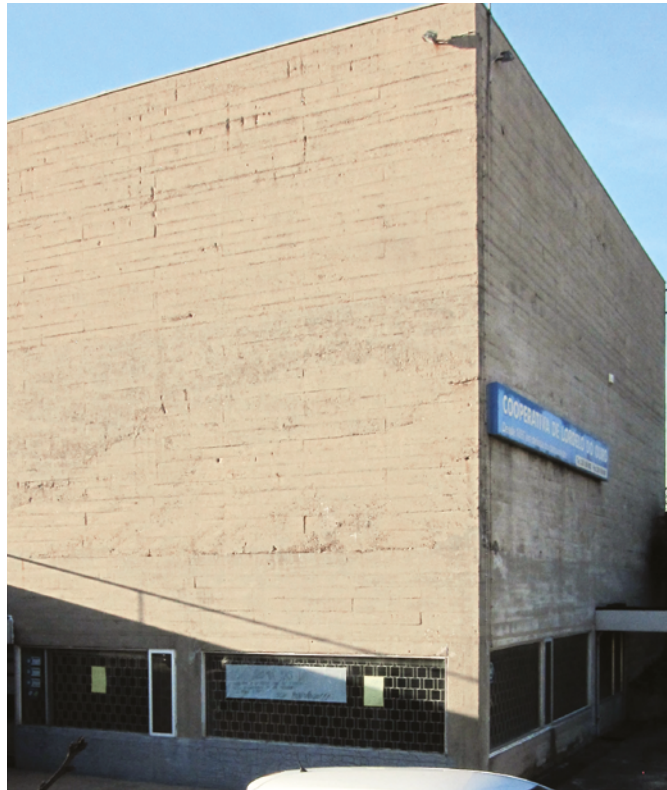
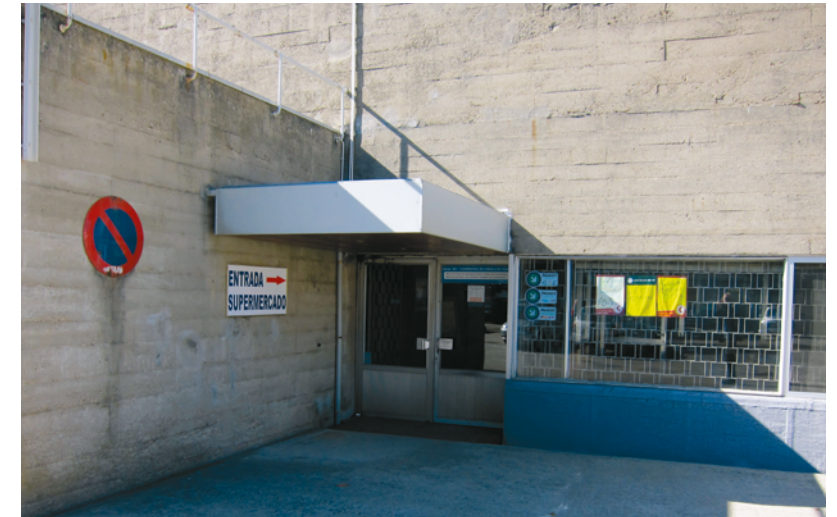
In parallel, it should also be said that some diffused deterioration phenomena (and related inappropriate alteration/repair interventions) occurred due to water infiltrations and leaks in roofing and drainage structures. Growing vegetation aggravated the initial material disintegration. Those problems have, in turn, caused other minor deteriorations such as biological patinas, particularly at ground level and intradoses. Besides this, the brackish atmosphere of the Atlantic caused the punctual detachment of the concrete surface in every elevation.

Fig. 1.64 to 1.80
Close-up views of the deterioration of exposed concrete surfaces in all the façades in a (clockwise) sequence around the Building (photos by the author 2017-19).

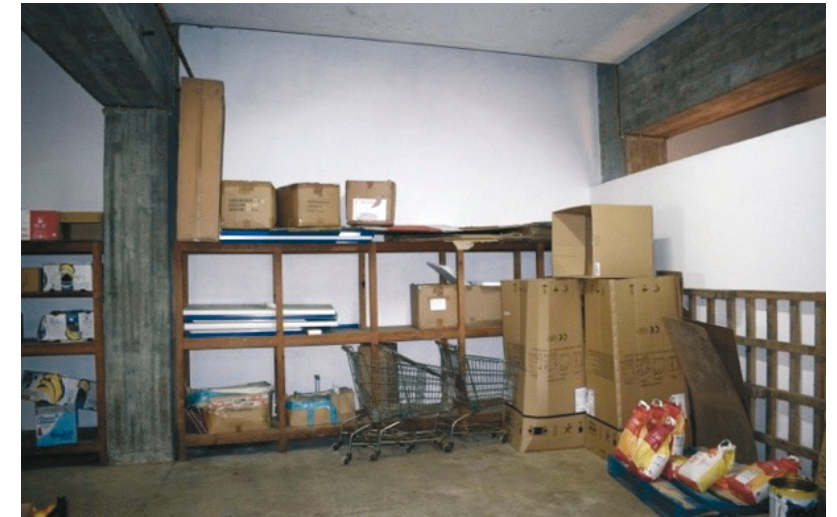
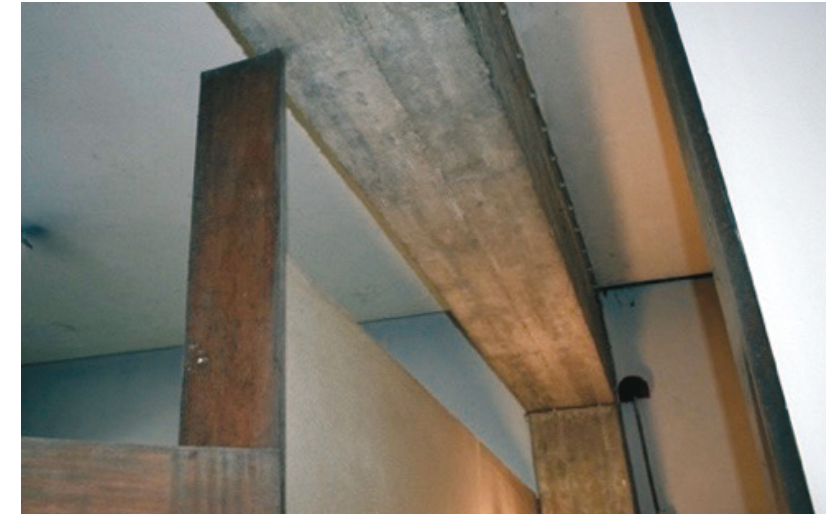
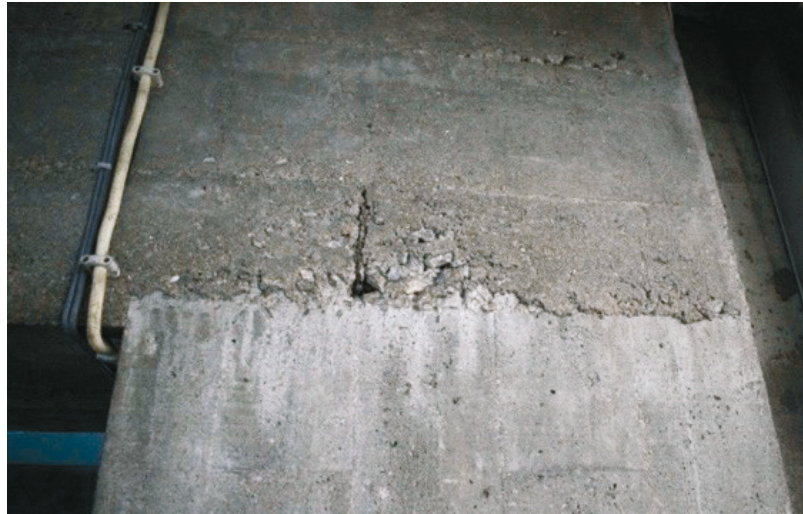
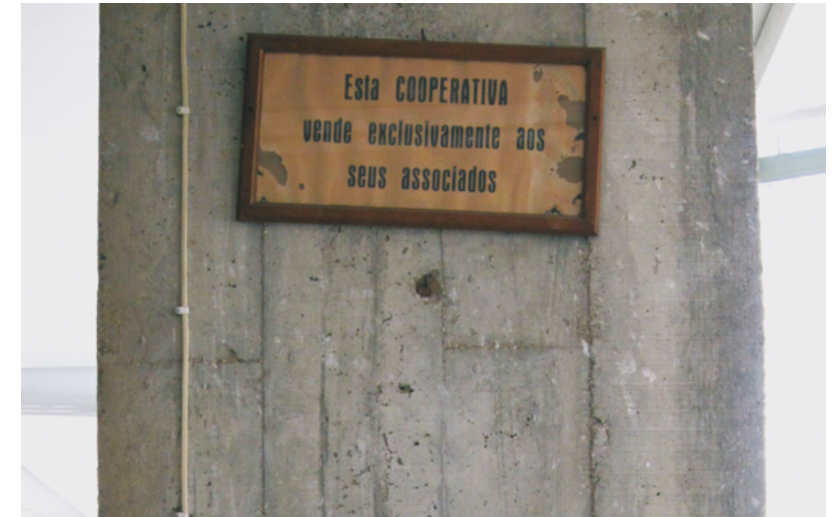
Fig. 1.81 to 1.85
Occasional spots of deterioration of exposed concrete surfaces inside the Building (photo by the author 2017-19).

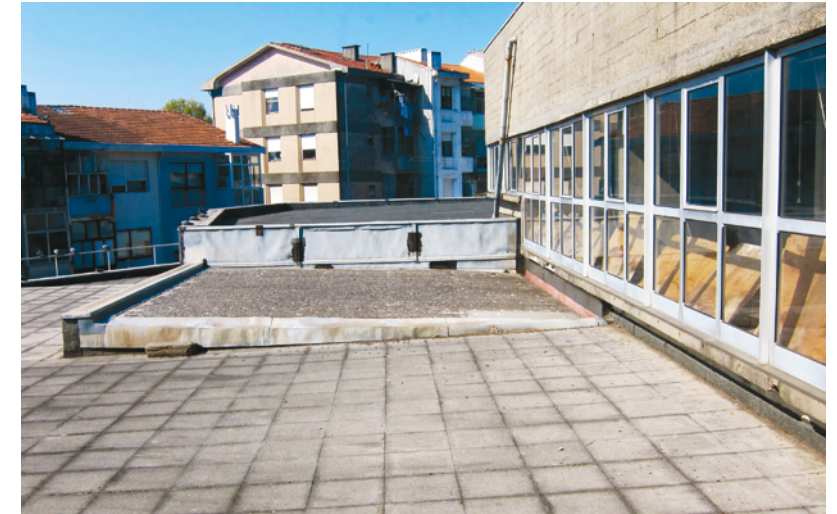
Fig. 1.86
Sales hall leaky
roof covering (photo
by the author 2017-19).

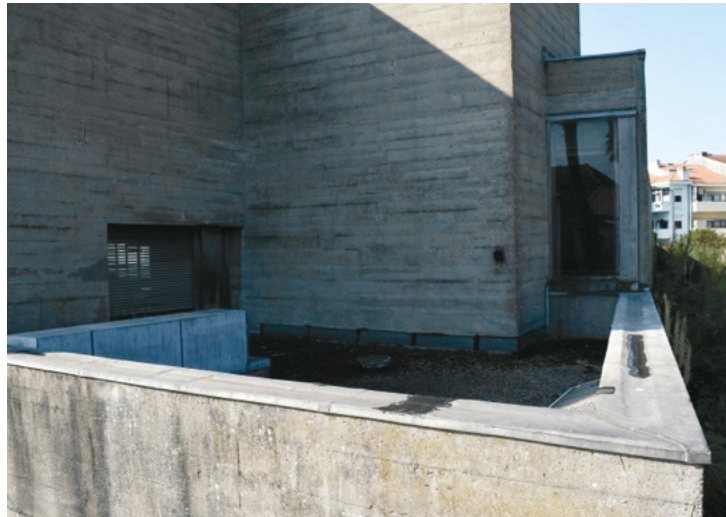
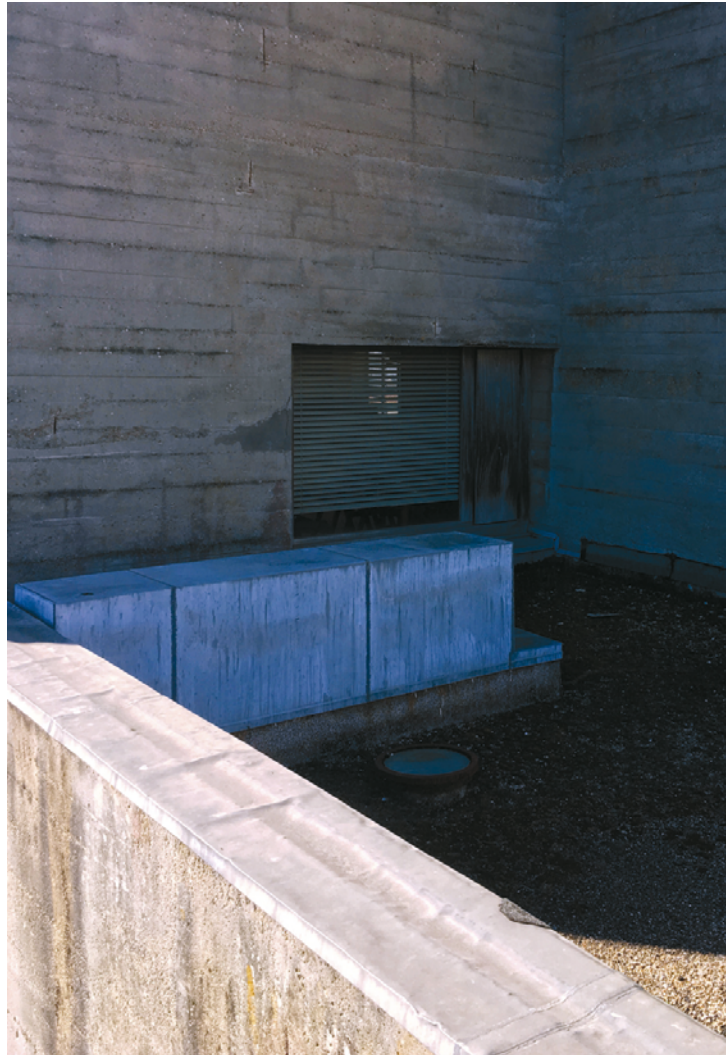
Fig. 1.87 and 1.88

A portion of the roof perimeter where is evident the loosening of the metal flashing, with consequent moisture infiltration inside the reinforced concrete walls (photos by the author 2017-19).

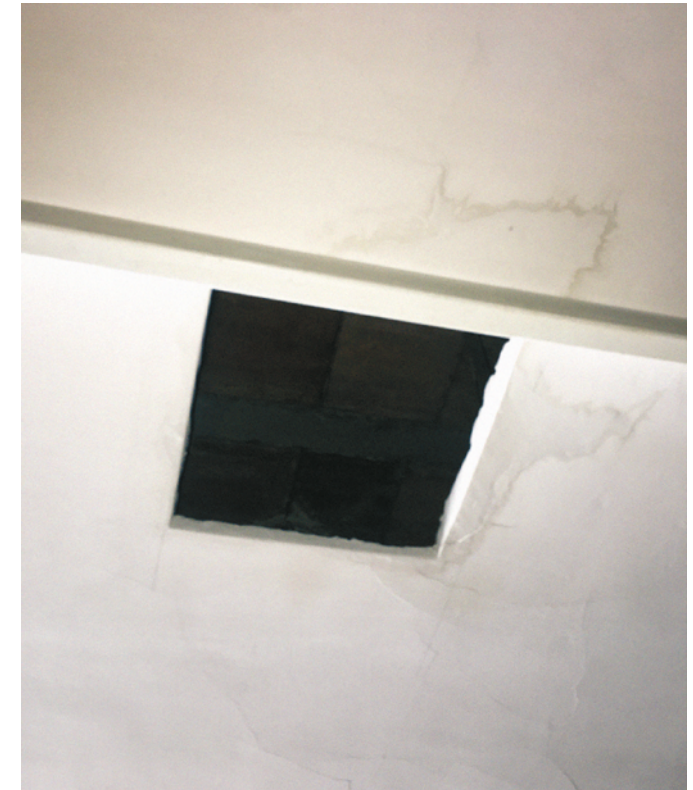
Fig. 1.89 and 1.90

Samples of the false ceiling damaged panels due to moisture (photos by the author 2017-19).

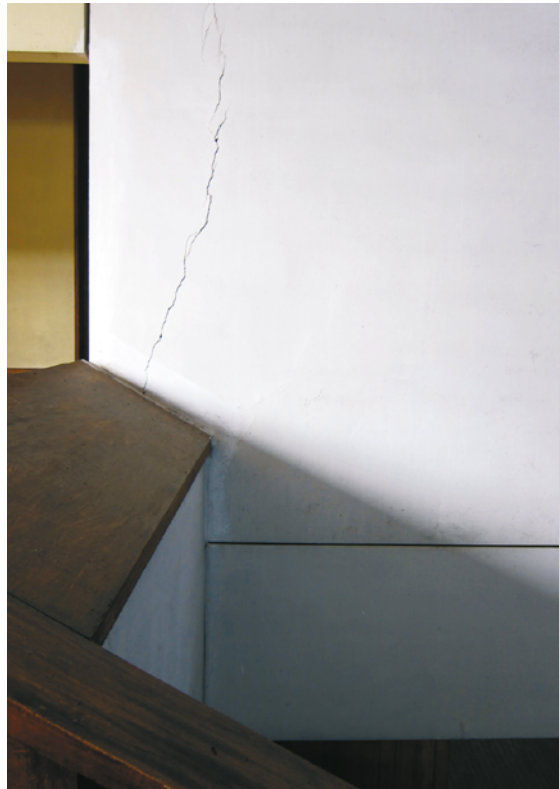
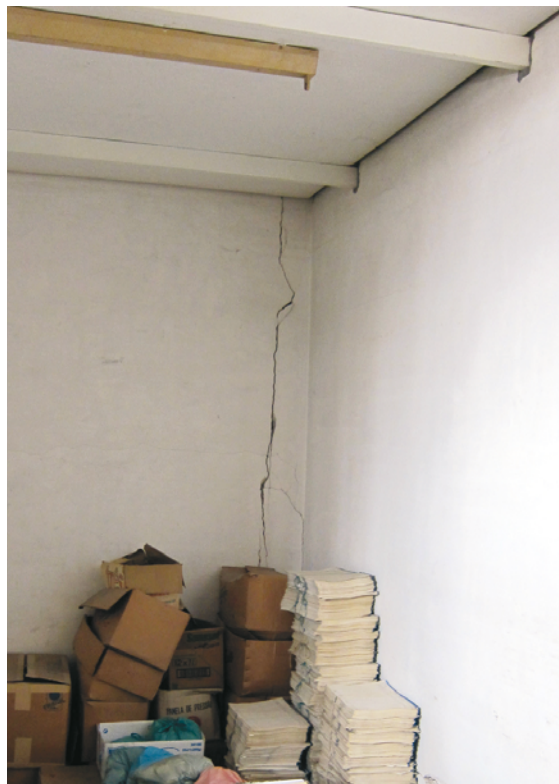
Fig. 1.91 and 1.92
Identification of cracks
affecting non-structural
walls (photos by the author
2017-19).

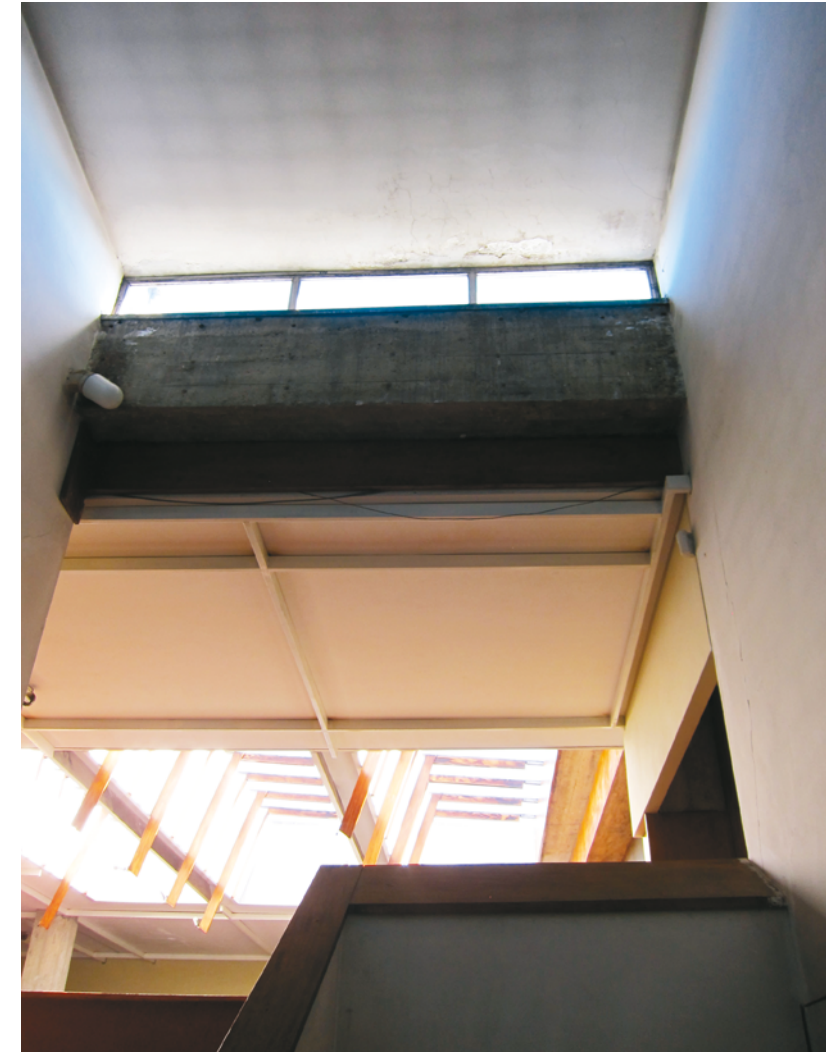
Fig. 1.93
Brick shaped marks
on the walls and at the
intrados of the roof slab
in the staircase (photo
by the author 2017-19).

Apart from this, an evident problem is that of brick shaped marks on the walls and at the intradoses of the roof slabs (where, obviously, the false ceiling is absent). Due to the lack of thermal insulation within the constitution of the walls, gaps of temperature occur upon the surfaces of different materials/elements; that is to say, since bricks have greater thermal resistance than the mortar that aggregates them, condensation phenomena translate into different types of behavior [Fig. 1.93].

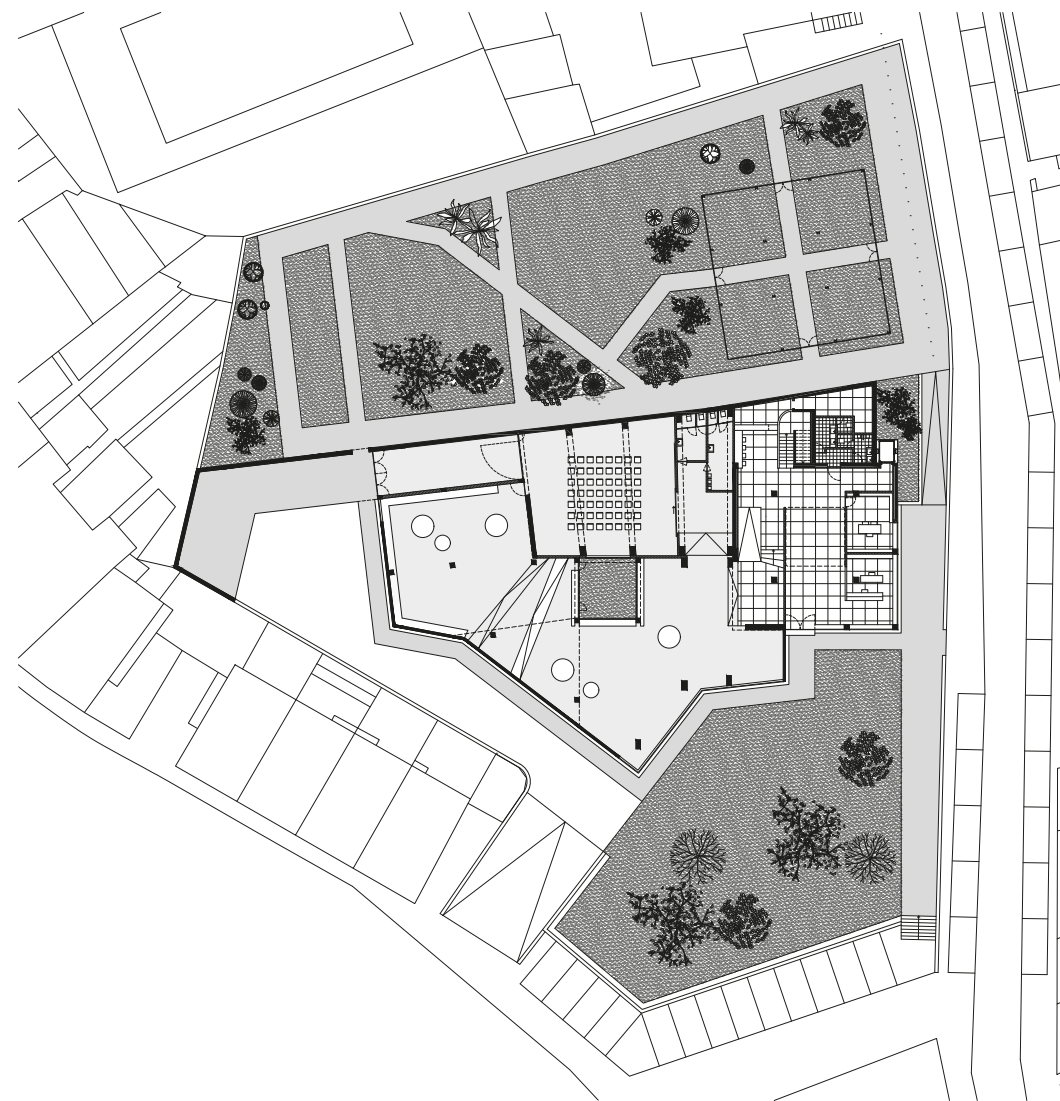
Fig. 3.2
Overall plan of the
Building's reorganization
in the proposal named
'The path' (drawing
by Álvaro Mendes
and Nuno Gonçalves).

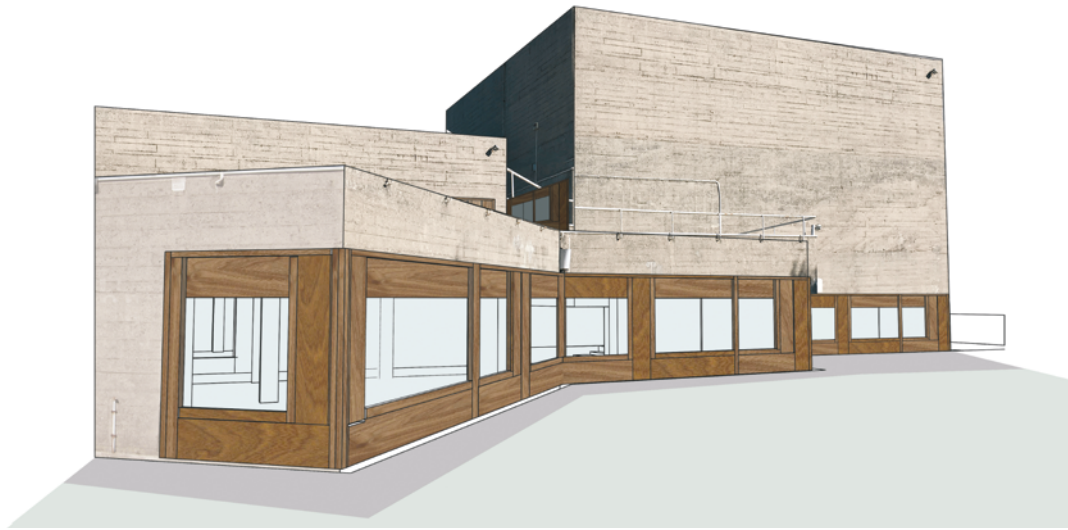
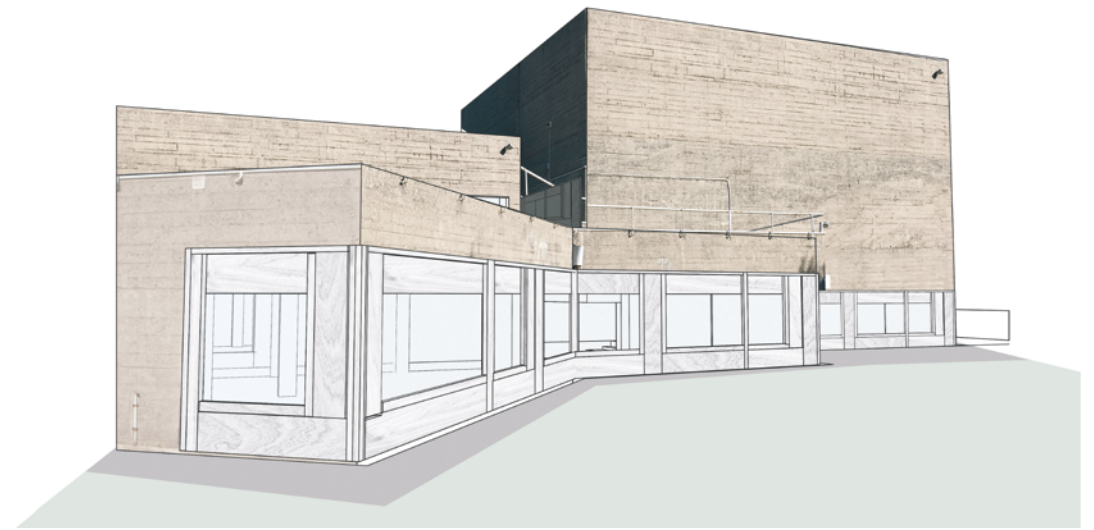
Fig. 3.16 and 3.17
Perspective views of
material rendering
of alternative paint
coatings for window
framing solution as
in Fig. 3.13 (drawing
by Álvaro Mendes and
Nuno Gonçalves).

it comes to the framework apparatus. As for the vertical section, another slight alteration consisted in the increased distancing of the wooden framework from the concrete surface, in order to absorb (by hiding) the insertion of the wall's thermal insulation layer. Therefore that scheme could eventually be defined as strictly driven by the reconstitution of the original tectonic expression of the Building. Finally, the proposal included the possibility of using aqueous white coating paint that could help protecting the wood and ensure greater durability. Notably, that was what Álvaro Siza purposely suggested to the Cooperative's management when questioned about the difficulty of maintaining wooden windows⁴³ [Figs. 3.13 to 3.16].

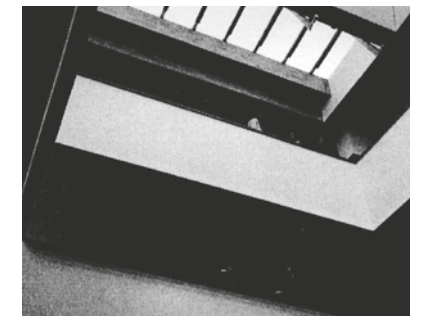
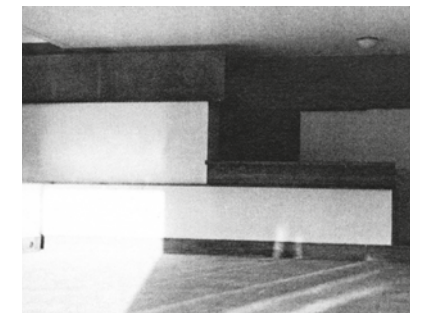
Fig. 3.24
Selected points' detailed construction sections of the false ceilings of the Building's perimeter walls with the original solutions and the low cost improvement proposal drawn 'side-by-side' (drawing by Inês Torres and Inês de Castro with historical photos 1960–63 Álvaro Siza Archive © Serralves Foundation).

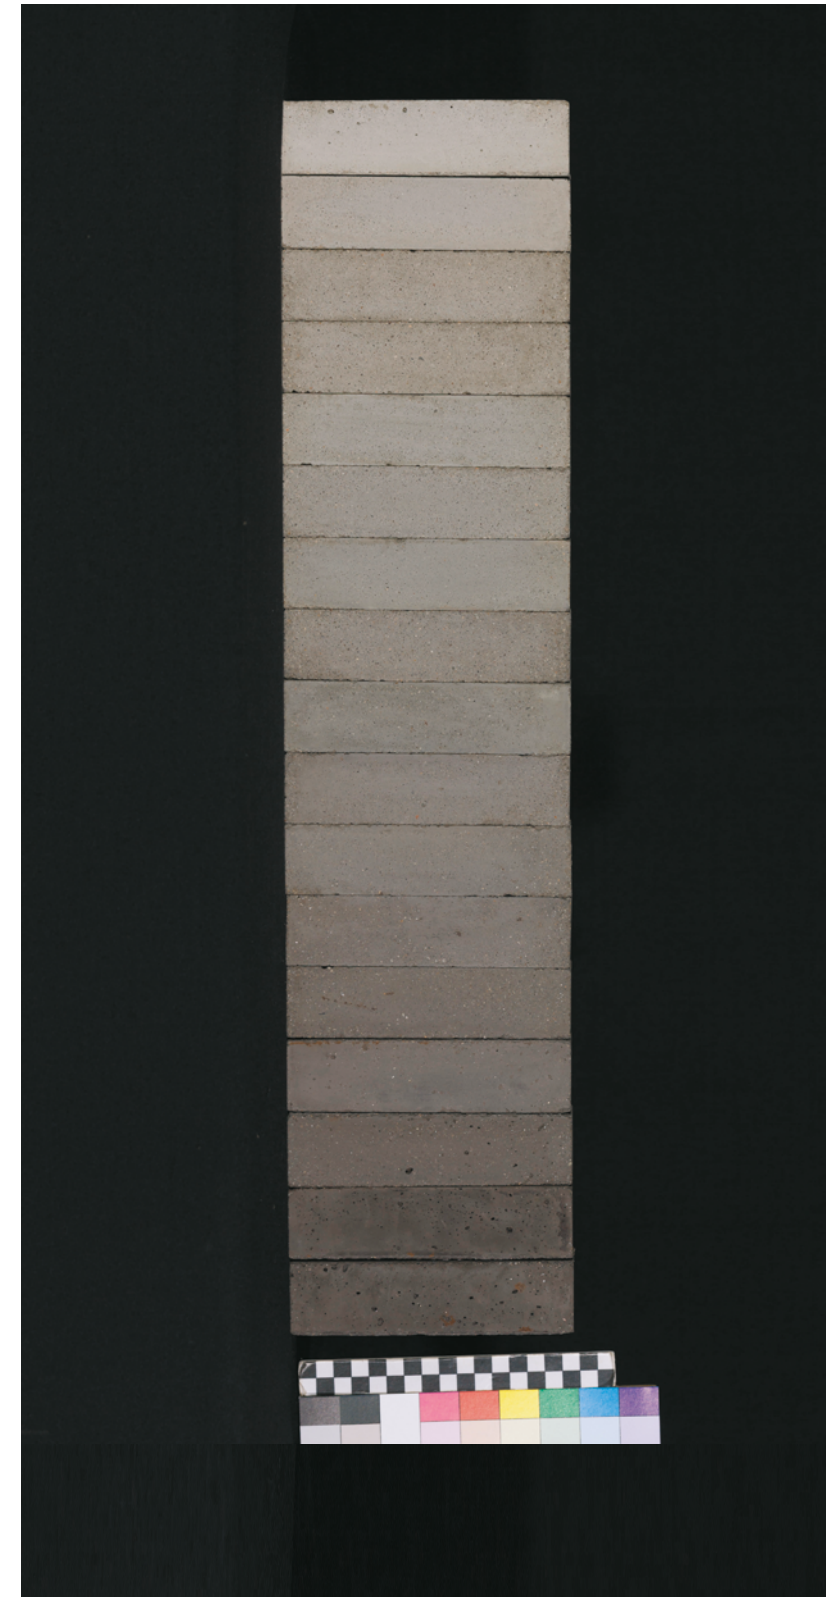
**Fig. 3.26**

Different shades of gray repair mortar samples to be used as matching palette according to Grey Concrete Restoration Method (GCR-method) (© CERis – Civil Engineering Research and Innovation for Sustainability of Instituto Superior Técnico of the University of Lisbon).

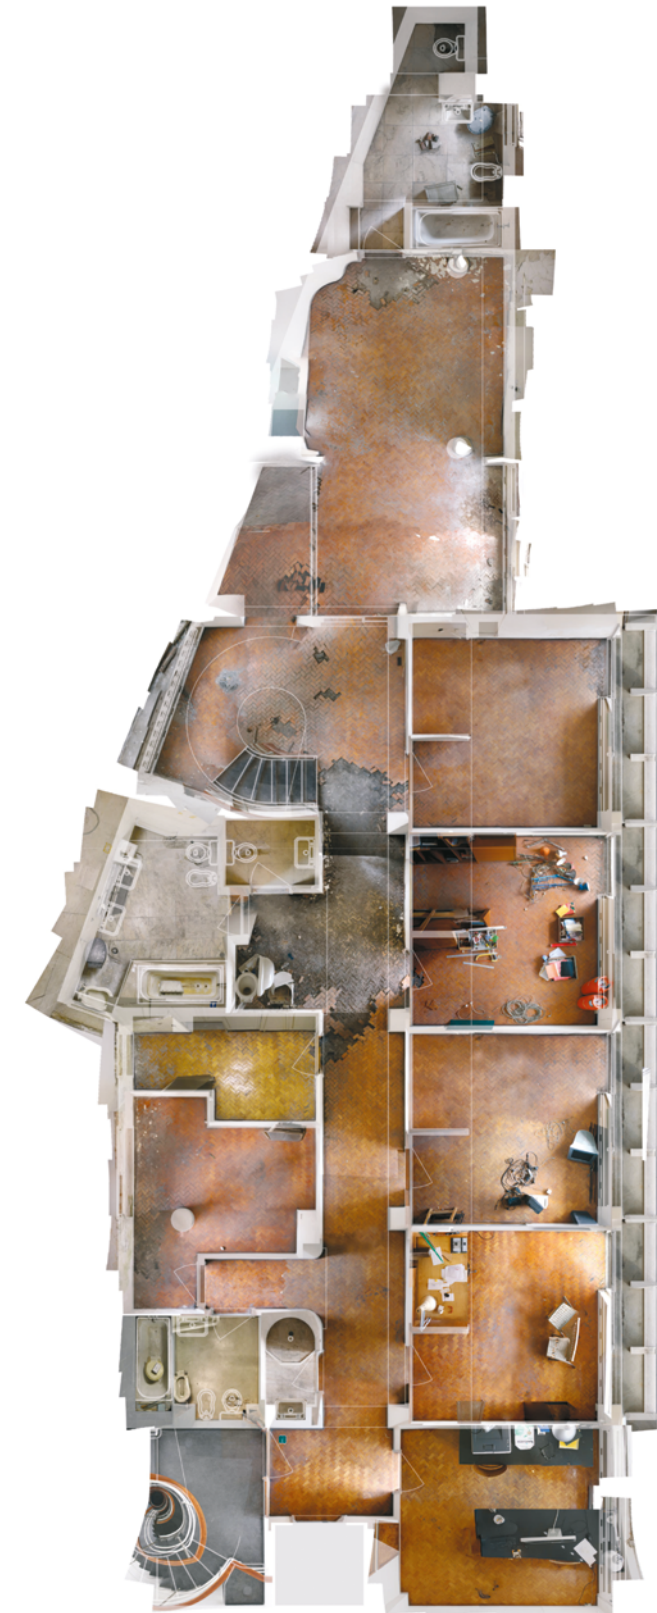
Fig. A.4
Examples of the ‘mapping of occupancies’ of the Penthouse of the Soares & Irmão building (architects Arménio Losa and Cassiano Barbosa, Porto, 1950–54), abstract from C. Maia *Op. Cit.*, pp. 364–365 and 386].
